ShowerChannel

Geelong Hospital, VIC

Project Design Brief

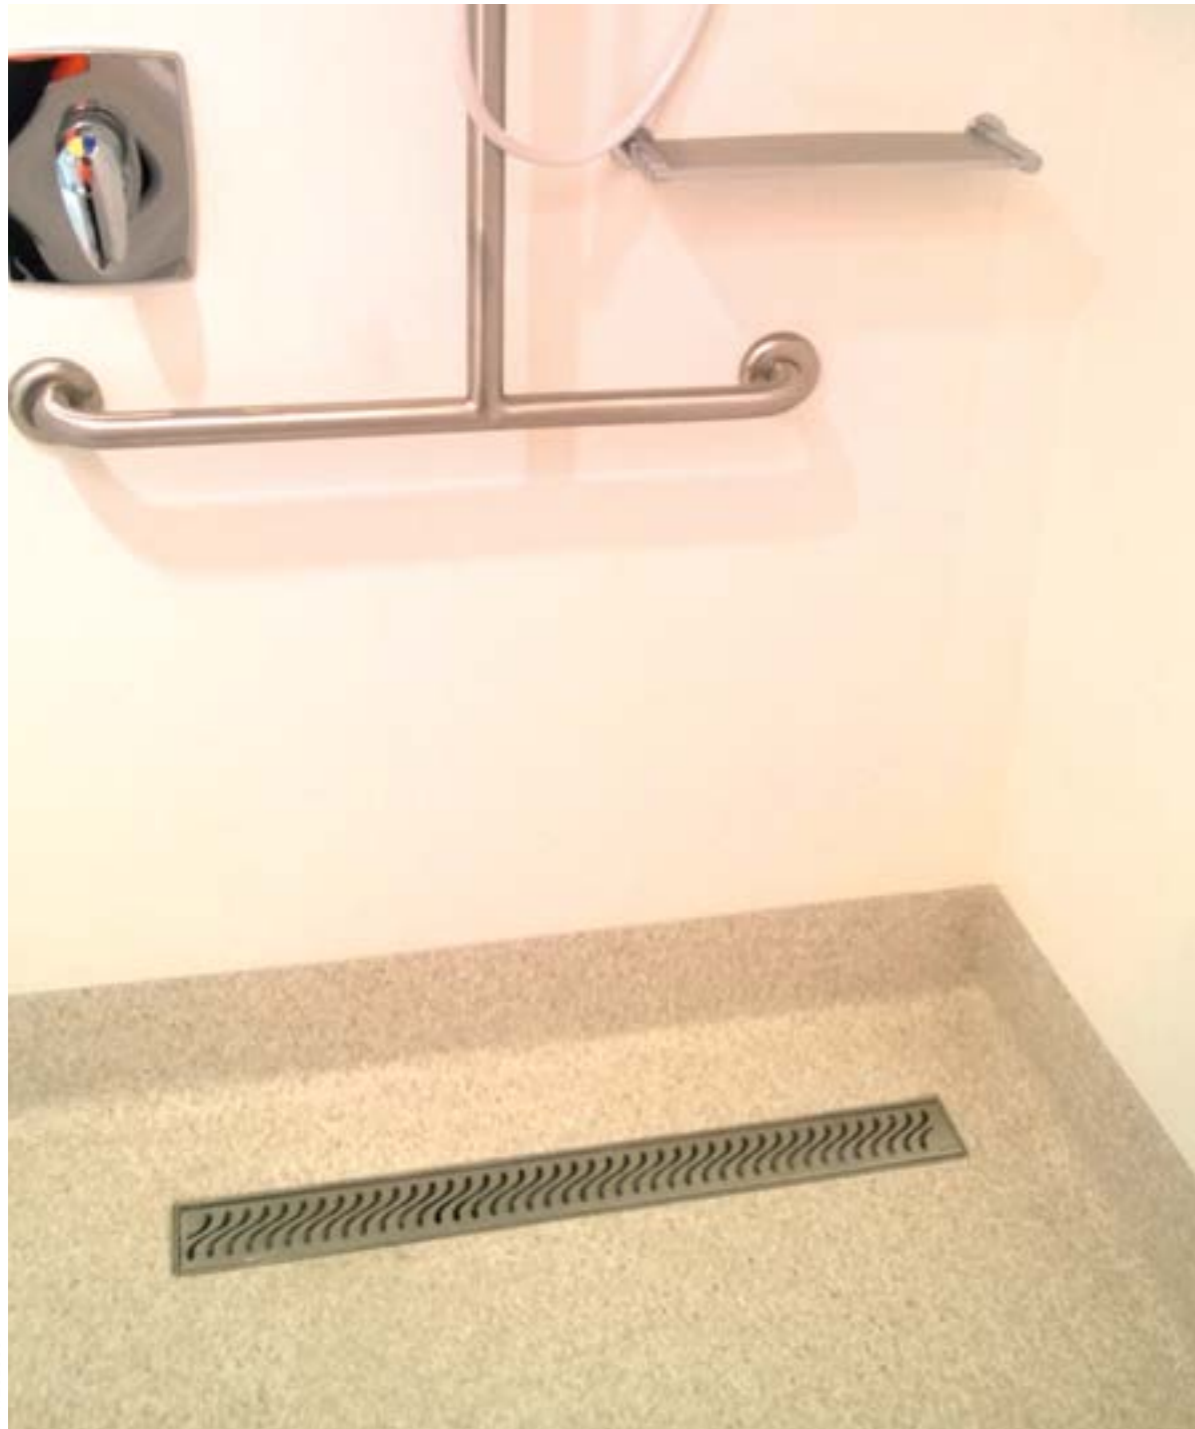
- QuARTz by ACO, ShowerChannel and Flag grate with an integral custom-made vinyl clamp system

- The Flag grate consists of large openings for the shower water to pass through
- ACO custom engineered a vinyl clamp system to provide a secure joint between the vinyl floor and the stainless steel channel, approved by designer and client
- The 'V' profile of the ShowerChannel ensures that no idle liquid sits in the bottom of the channel, preventing stagnant water and odours and also enables easy cleaning
